**FRENCH RIVER BASIN
DUDLEY, MASSACHUSETTS**

**LOWER MERINO POND DAM
MA 00109**

**PHASE I INSPECTION REPORT
NATIONAL DAM INSPECTION PROGRAM**

OCTOBER 1978

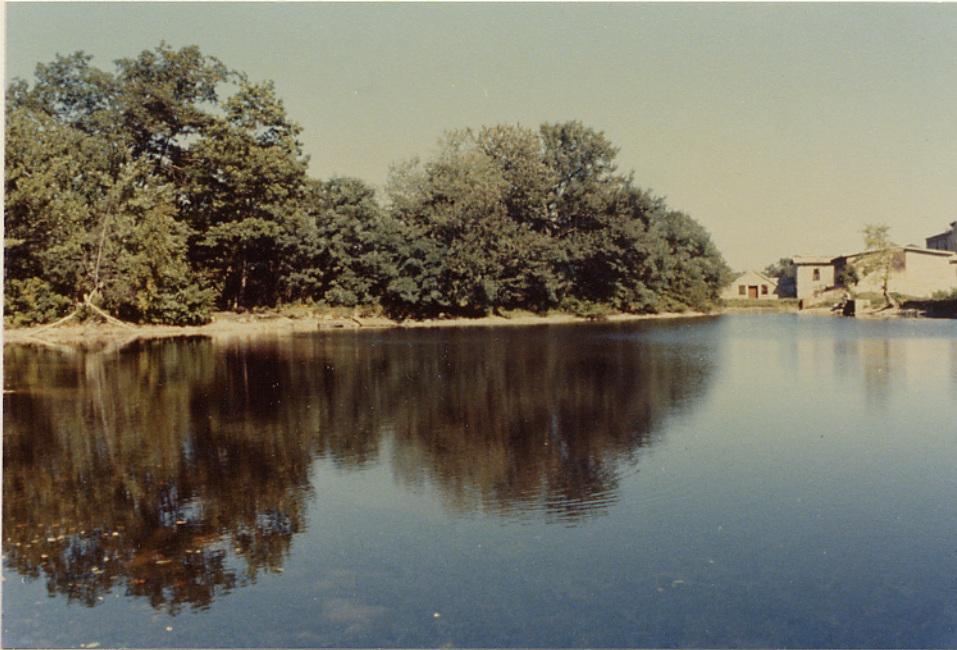
VIEW FROM UPSTREAM OF DAM

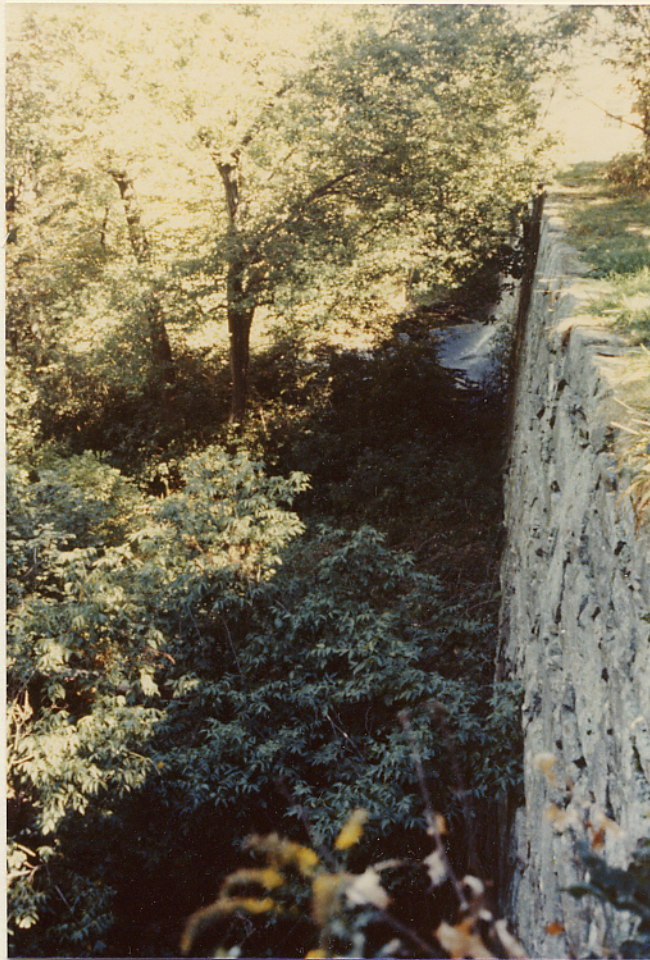
NO. 1 DOWNSTREAM STONE MASONRY WALL

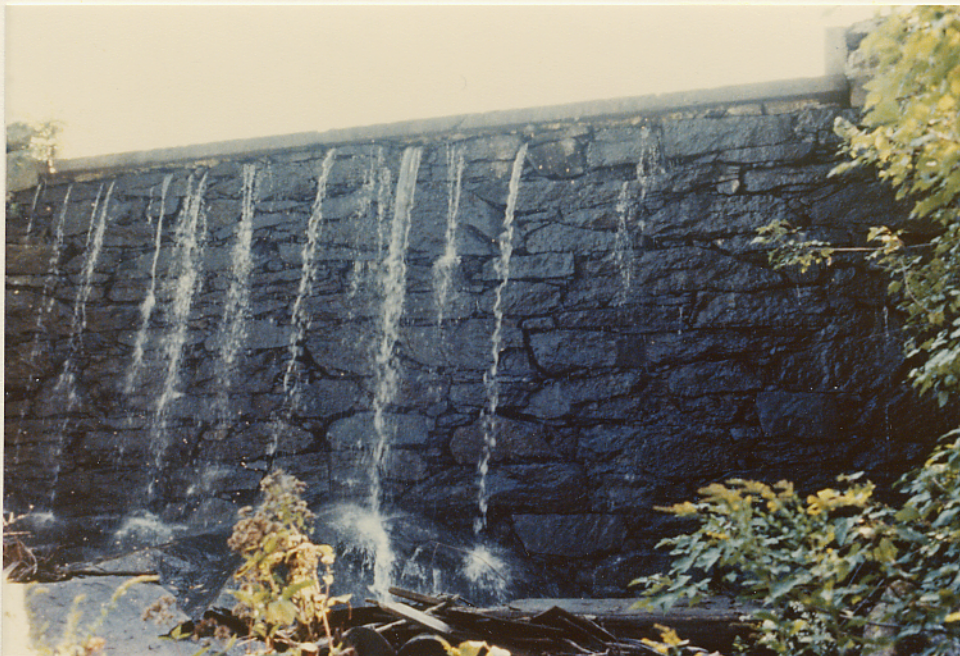
It is recommended that a more detailed investigation be initiated immediately to evaluate the stability of the dam and the seepage along the face of the downstream wall and at the abandoned outlet. The severe leaking near the spillway is apparently more recent than 1972. The fractures in the masonry blocks should also be investigated immediately.

NO. 2 LEAKAGE BENEATH SPILLWAY CREST

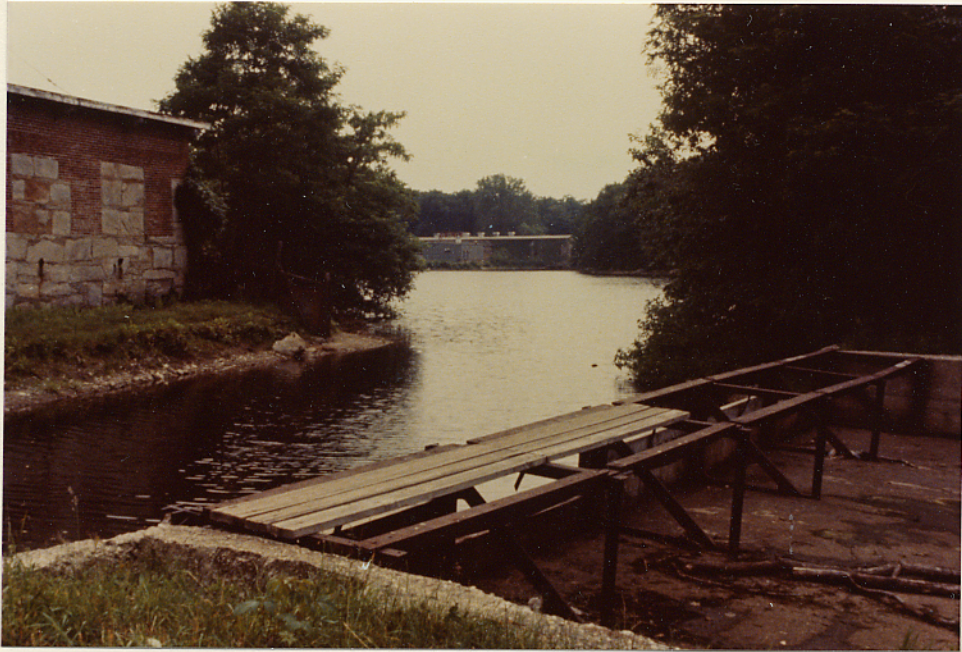
NO. 3 SPILLWAY CREST LOOKING UPSTREAM

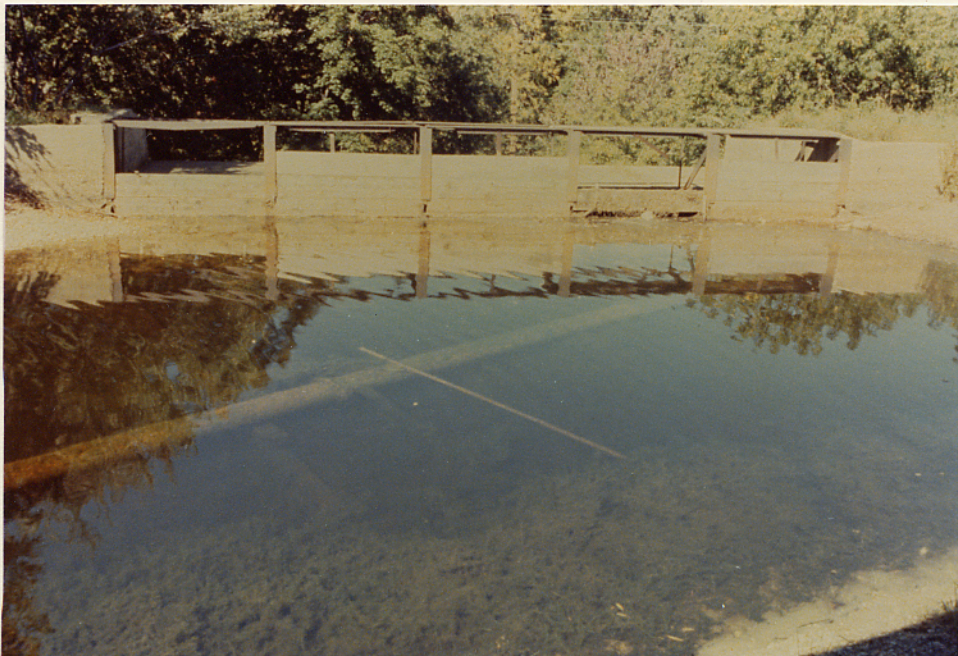
A submerged pipe was visible in the pond near the spillway. The Owner indicated the pipe was ungated but blocked and it terminated in the old wheelhouse. The Owner also stated that the pipe was leaking into the buildings.

NO. 4 PIPE IN SPILLWAY CHANNEL

- a. Operating and Maintenance Procedures. The dam and spillway are not adequately maintained. It is recommended that the Owner accomplish the following:
 - (1) Install an operable gated outlet in addition to the outlet for fire protection.
 - (2) Adequately seal or remove the leaking pipe leading to the wheel house.

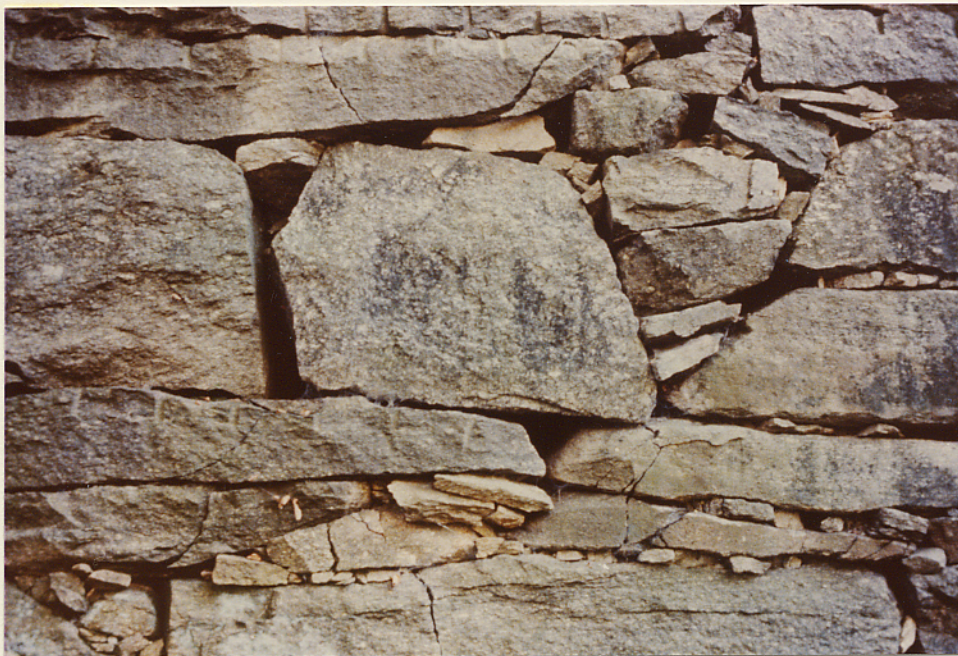
- b. Dam. The dam is in poor condition. The crest is heavily overgrown with trees and brush. The vertical stone masonry wall appeared in satisfactory condition although some vertical fractures were noted in the lower masonry blocks. The fractures are prevalent within the lower third of the dam and are of concern. One smaller stone filling a void appeared crushed and many others are missing. The upstream slopes were eroded near the crest. One tree was observed growing within the face of the spillway abutment wall. Otherwise, the wall was free of vegetation. Several leaks were noted at the face of the wall and the locations are shown in Figure B-1 of Appendix B. A large seepage zone was noted at the northwest spillway abutment extending from the spillway about 5 feet near the top of the downstream wall to about 10 feet at the bottom. A very small seepage area was noted about 110 feet from the northwest spillway abutment at the lower part of the downstream wall. A small area in front of the toe of the downstream wall about 45 feet from the northwest spillway abutment appeared to be leaking. Fill over this area covered the toe of the wall. A seepage area was noted along the toe of the south spillway abutment and abutment to the mill building.

NO. 5 FRACTURES IN DOWNSTREAM STONE MASONRY WALL

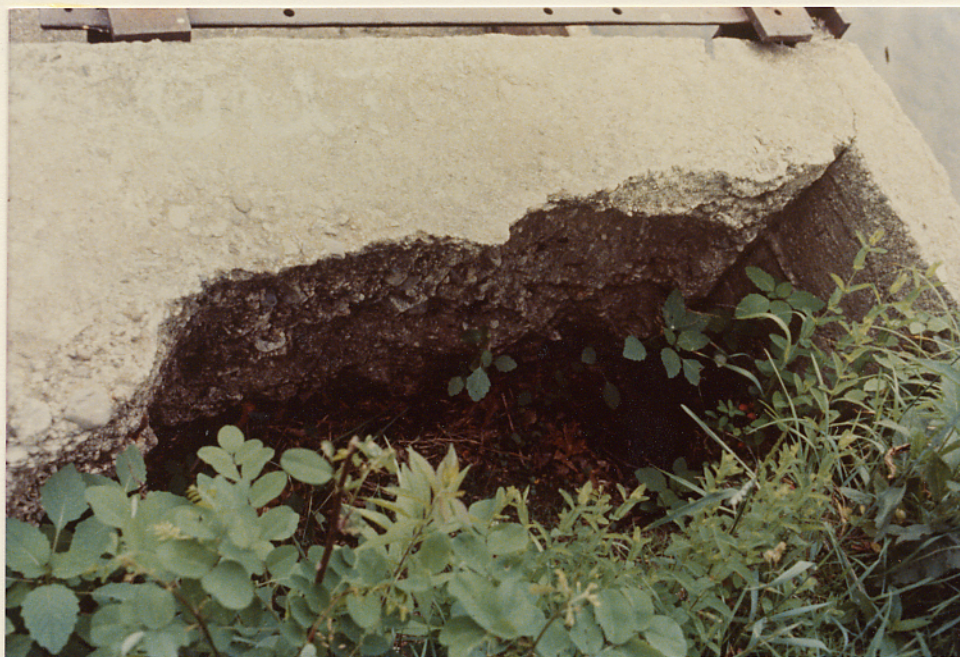
- c. Appurtenant Structures. The concrete of the spillway weir and sidewalls is in fair condition. The most noticeable deficiency occurs at the sidewalls where the fill has been eroded from behind the walls on each side of the spillway. There, the concrete is badly spalled. Several cracks were evident in the concrete weir. The flashboards on the spillway leaked between the bottom of flashboard and spillway weir. The flashboards are rigidly supported by a footbridge superstructure. It did not appear to be an easy task to remove the flashboards during flood flows, nor did it appear that the boards themselves would fail during high overtopping flows. The downstream wall at the spillway leaked in several areas near the top, most noticeably between the concrete cap and top of the masonry blocks. The downstream channel was cluttered with large logs and other debris.

NO. 6 EROSION BEHIND SPILLWAY SIDEWALL

- (3) Repair both the washout area behind the side walls and surface depression over the abandoned outlet to the wheel house.
- (4) Remove all trees and brush from the crest of the dam, and clear debris for the downstream spillway area.
